NPIC/R-1606/63 December 1963

PHOTOGRAPHIC INTERPRETATION BRIEF

SEMPLAK AIRFIELD, INDONESIA

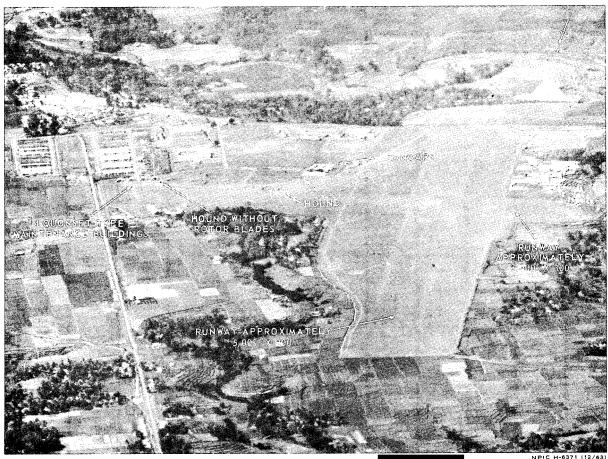
FIGURE 1. SEMPLAK AIRFIELD, INDONESIA,

Semplak Airfield (Figure 1) is situated 1.3 nm NW of Semplak and 4 nm NW of Bogor. It has 2 serviceable sod runways, one approximately 5,000 x 300 ft NNE/SSW and the other approximately 3,000 by 300 ft ESE/WNW. Facilities include 2 hangars with an associated apron, 4 quonset-type maintenance buildings and

7 support buildings. A barracks area just east of the airfield contains 22 barracks (10 apparently deteriorated), 2 large administration buildings, and 13 support buildings.

Aircraft observed were 5 Hound helicopters (one without rotor blades).
